FOCUSED SITE INSPECTION PRIORITIZATION SITE EVALUATION REPORT

NATIONAL DSPL #1 2424 W. CLARKE STREET PEORIA, ILLINOIS

CERCLIS ID NO.: ILD980901581

Date Prepared: September 28, 1995

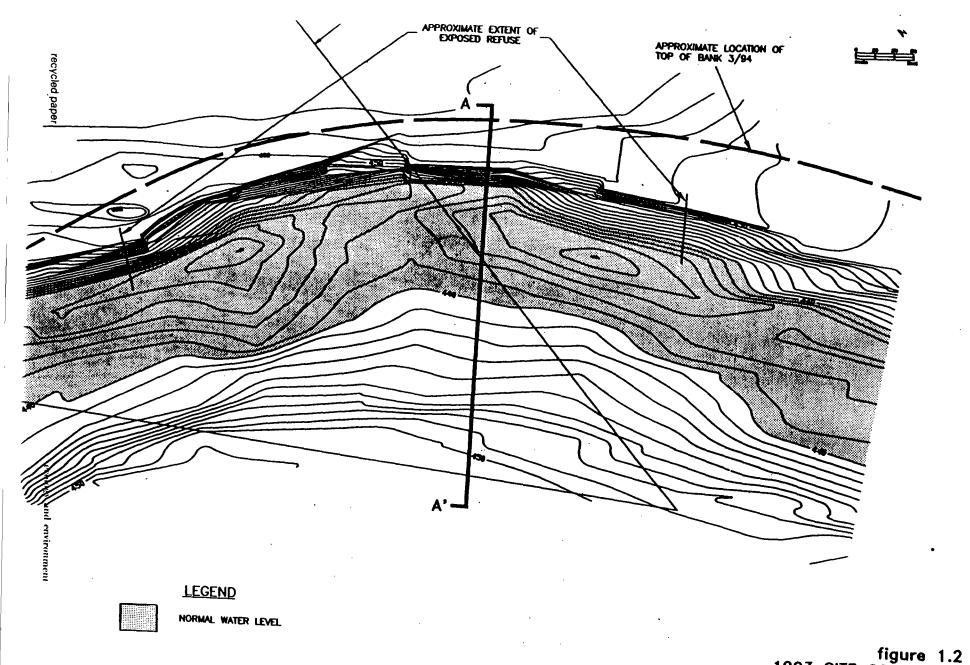
figure 1.2 1993 SITE CONDITIONS Kickapoo Creek Bank Repair

By 1993, the hydraulic situation resulted in sufficient erosion of the stream bank to expose waste that had been buried during the operation of the landfill. A repair of the bank was proposed by the previous landfill operator and the affected landowners. Before repair could be performed, the extended flood period of 1993 occurred. During this extended period of high flows, the stream has eroded an additional 30 feet into the bank of the outside of the bend and the landfill. Figures 1.2 and 1.3 show the topography in the spring of 1993 and a typical cross-section of Kickapoo Creek at the most extreme exposed portion of the landfill. Figure 1.2 also shows the location of the stream bank in 1994 after the flooding.

The purpose of this detailed design report is to present a proposed repair to the landfill cover and adjacent stream bank that will provide long-term protection from erosion.

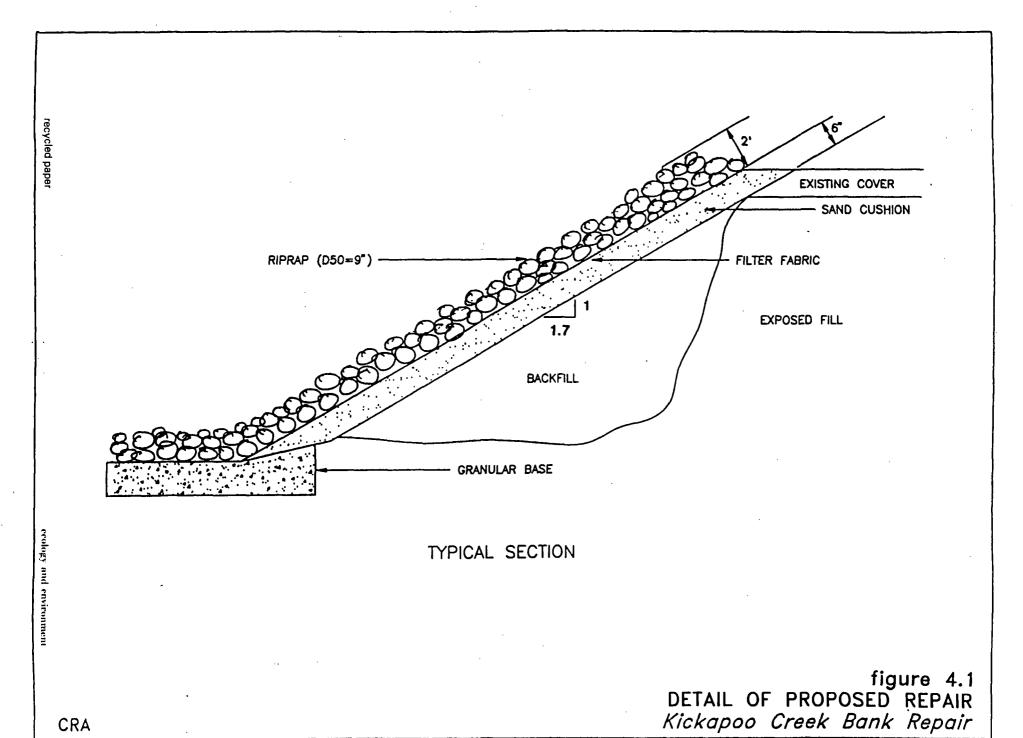
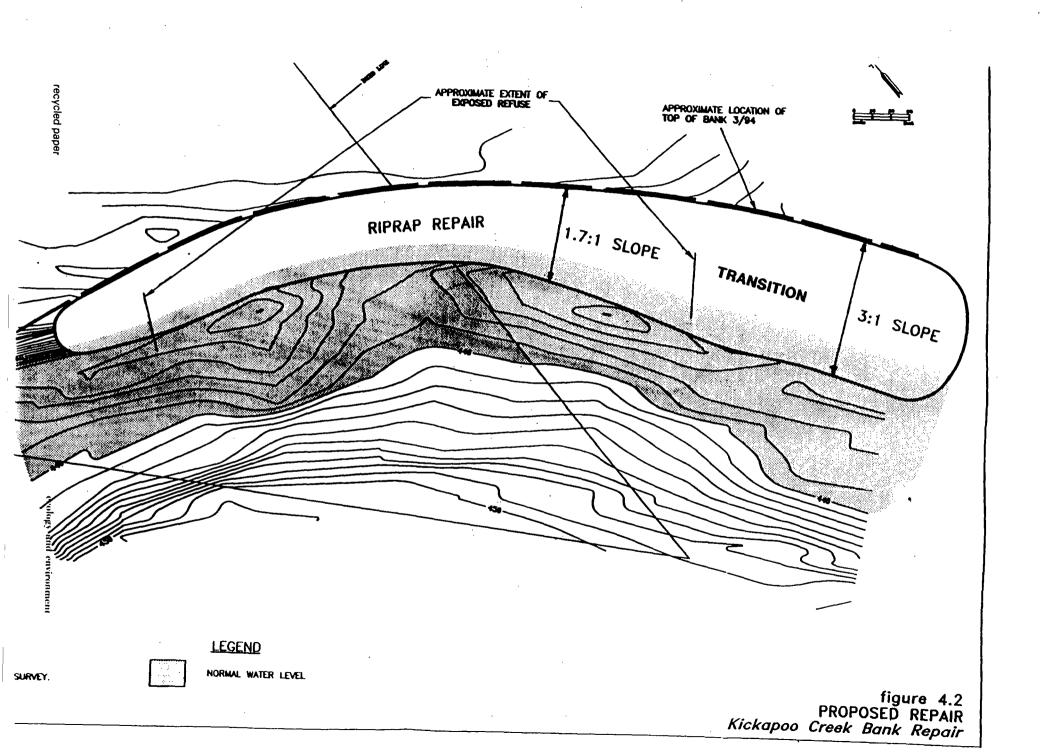
Figures 4.2 and 4.3 represent the same area after the proposed repair. Figure 4.2 shows the realigned stream bed with the areas of construction designated. Figure 4.3 shows the cross-section of Kickapoo Creek after the grading of the bank and placement of the geotextile matrix. As can be seen in this figure, the cross sectional area of the stream bed is at least as large as the pre-1993 stream bed.

In the 100-foot long section of eroded stream bank directly downstream of the landfill, the slope of the bank would transition to a minimum slope of 3:1. A 6-inch sand blanket would be placed on the regraded slope and covered with a filter fabric. The filter fabric would be covered with riprap to protect against further erosion. The balance of the bank downstream of the rip rap repair area to the end of the bend (approximately 100 feet) would be revegetated to resist erosion.
